## MITIGATING THE COST OF NOT KNOWING IN SHIPS

THE CHALLENGE	THE SOLUTION	THE BENEFITS
Map corrosion in ship deck plates quickly without removing coatings or linings	Pulsed eddy current solution enabling scans through coatings and linings	Enables the efficient mapping of corrosion in deck plates, effectively mitigating the cost of not knowing

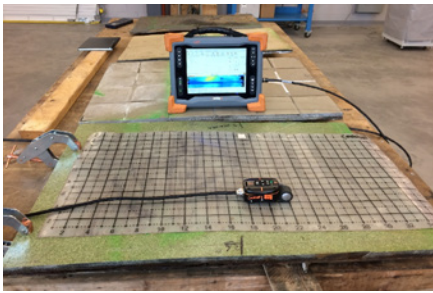
Corroded plate used in testing

In this particular application, the carbon steel deck plate extracted from a decommissioned ship and targeted for inspection was approximately 5.4mm (0.213 in) in nominal thickness and the lining 20.0mm (0.787 in). The far side of the plate featured several other elements such as welds and stiffeners.

Corrosion on the sides of the plate pushed the lining upward, separating it from the steel plate by close to 7cm (2.8 in) on the left side. Bulges in the lining were also visible, the result of ferrous oxide buildups.

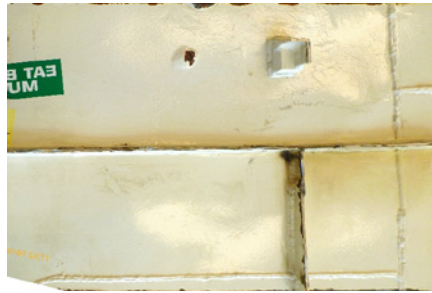
Corroded plate underside

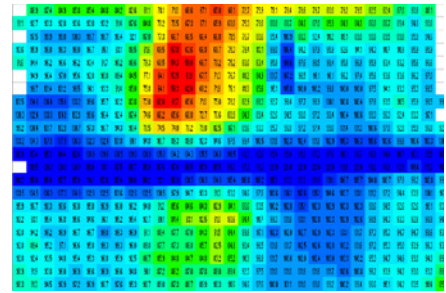
First scan, sides clamped, along stiffeners

Considering the thickness of the deck plate, lining, and corrosion product in this application, our engineers used a small PEC probe. All our scans were performed at a grid resolution of 25x25mm (1x1 in). For the first dynamic scan, clamps were used to close the gaps between plate and lining (see illustrations on the next page).

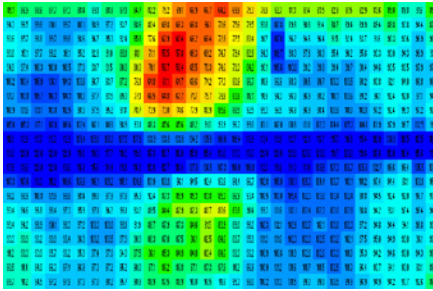
Second scan, no clamps, along stiffeners

To answer these questions, our engineers re-scanned the plate without the clamps to leave the gap between it and the lining open. The second scan of the plate revealed that, when compared to the first, data was not significantly affected by the gap or oxide buildup.

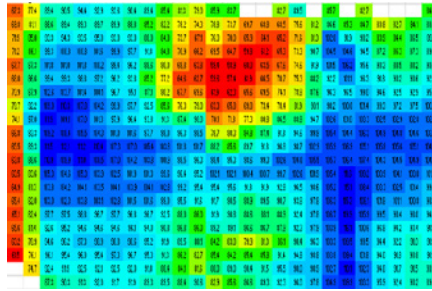
Third scan, no clamps, perpendicular to stiffeners

A third scan was performed perpendicular to the stiffeners. Based on this scan, our engineers concluded the following:

- When scanning along the stiffeners, they are visible in a 50–75 mm (2–3in) wide line.
- When scanning perpendicularly to stiffeners, their signals are weaker, but spread across a wider area.

We could therefore conclude that scanning along stiffeners will help better position them, while maximizing the detection of corrosion in close proximity to them.
