## Inspecting In-Service Storage Tank Annular Rings for Corrosion

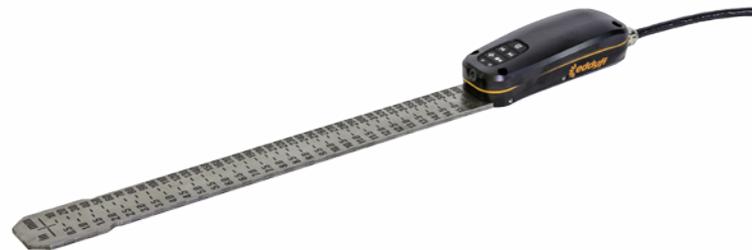
The **tank floor probe** is specifically designed for this type of inspection. With its super-thin 4.8 mm (0.2 in) titanium blade, and liftoff tolerance up to 13 mm (0.5 in), the probe can slide up to 400 mm (16 in) under a tank floor's edge, enabling it to assess the remaining wall thickness of this critical region exposed to corrosion.

The probe also has built-in remote controls and status LEDs, which allows one operator to perform the inspection. Furthermore, the tank floor probe's underside is magnetically shielded, maximizing sensitivity for optimal component analysis and protection against signal distortion from potential ferromagnetic structures. Finally, the probe's titanium blade is designed to withstand the harshest field conditions.

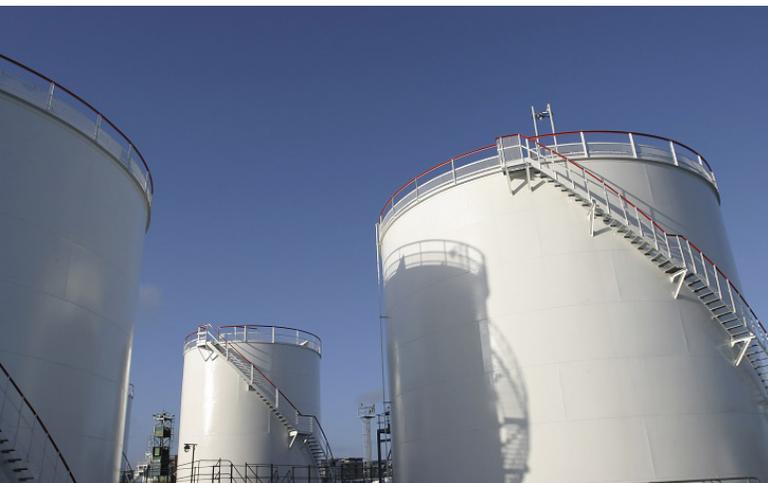
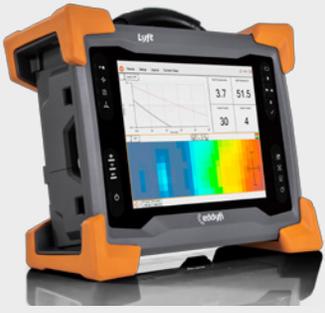
The Lyft instrument is sealed and designed for IP65. Its magnesium alloy casing is tough, water and dust resistant, and cools without any external air exchange. The adjustable stand, the top handle, and four corner anchor points make it practical for on-site inspections.

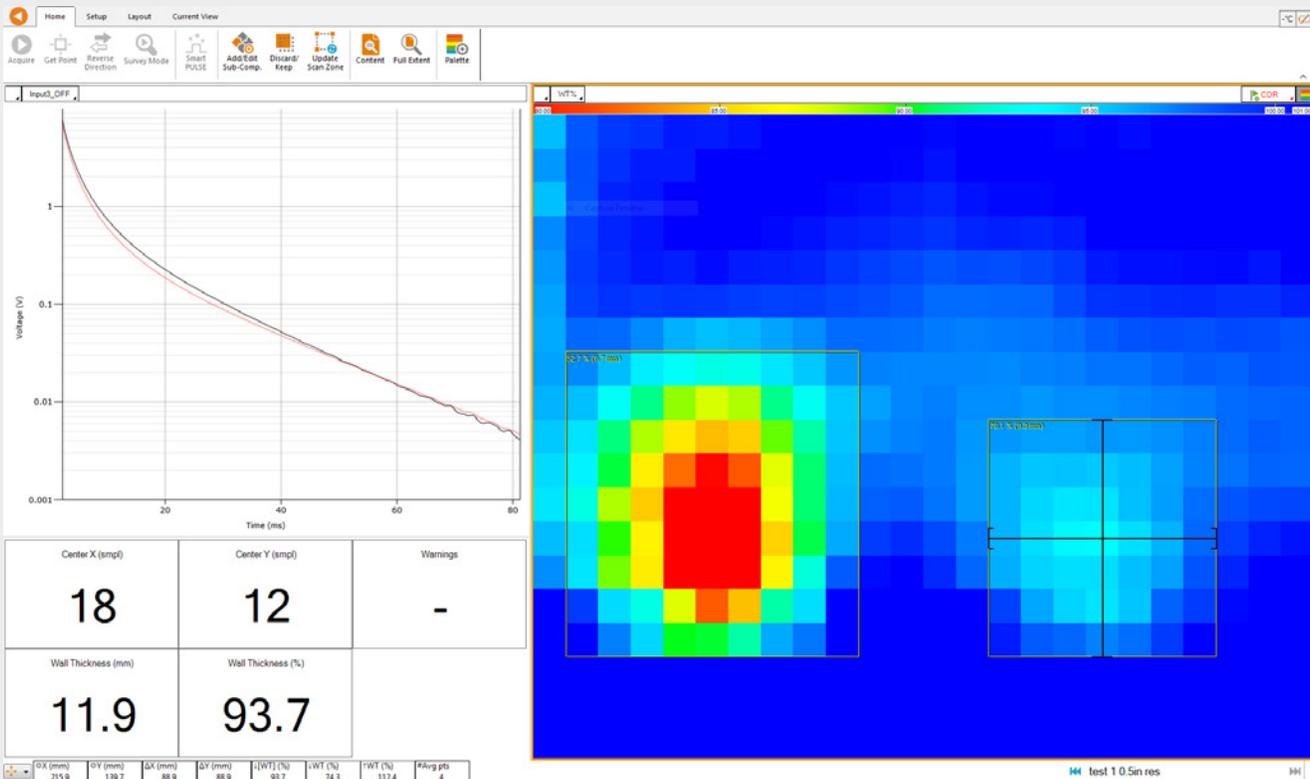
In the example below, Lyft was able to detect thinning caused by corrosion under the tank wall: gradual wall loss 6.5 mm (0.26 in) deep, 50.8 mm (2 in) wide, 190.5 mm (7.5 in) long, 50.8 mm (2 in) from the edge of the tank floor (left-hand indication in C-scan). It was also able to detect wall loss 1.9 mm (0.075 in) deep, 76.2 mm (3 in) in diameter, 76.2 mm (3 in) from the edge of the tank floor (right-hand indication in C-scan).
